WATER QUALITY RESTORATION PLAN AND TOTAL MAXIMUM DAILY LOADS FOR THE SUN RIVER PLANNING AREA

DECEMBER, 2004

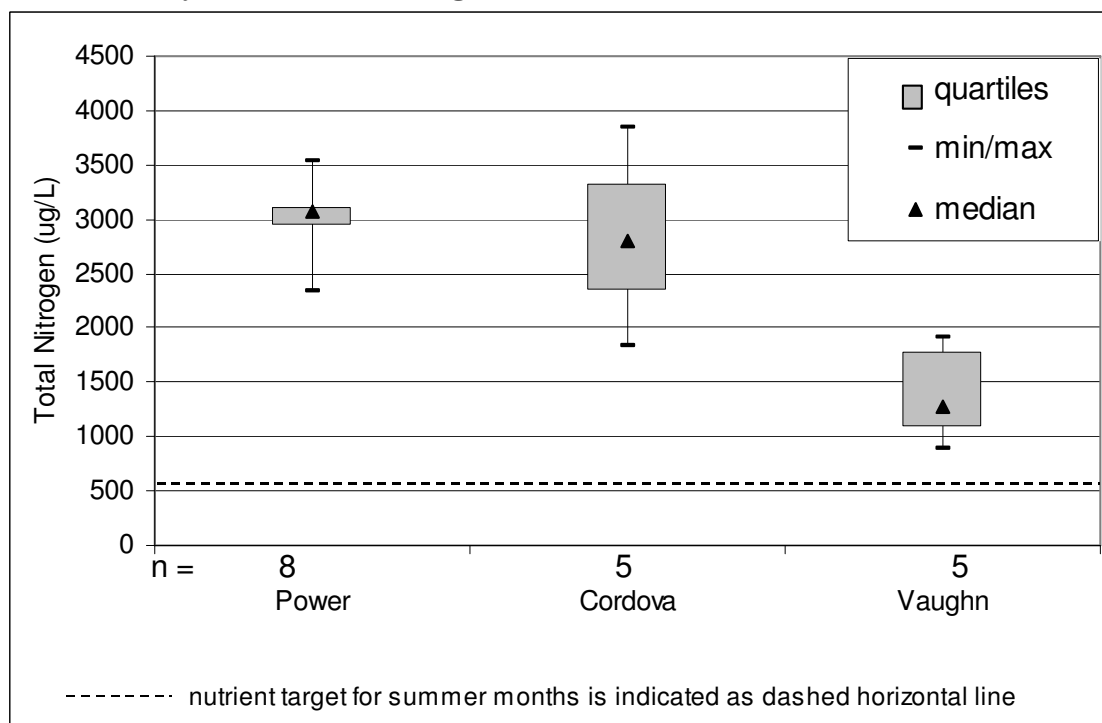
**Figure 8-9. Muddy Creek Total Nitrogen Summer Concentrations (1996- 2003).**

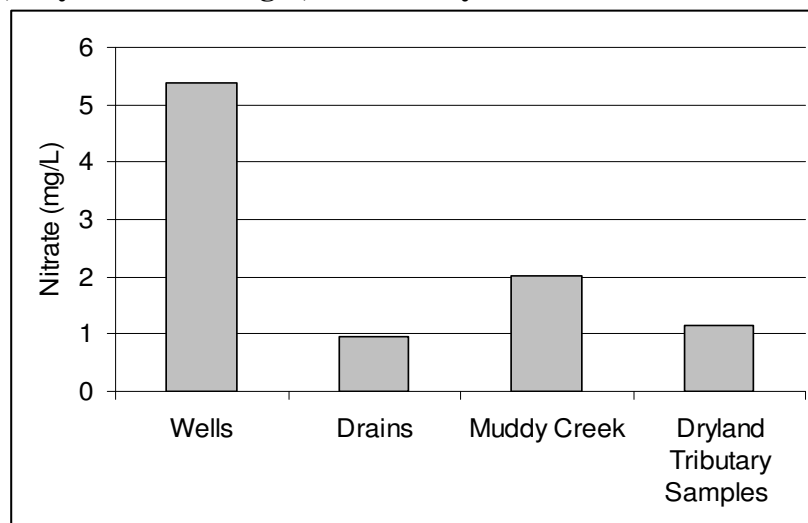
Figure 8-10. Mean Nitrate Concentrations in Greenfields Bench Groundwater, Drainages from the Bench, Dry Land Drainages, and Muddy Creek.

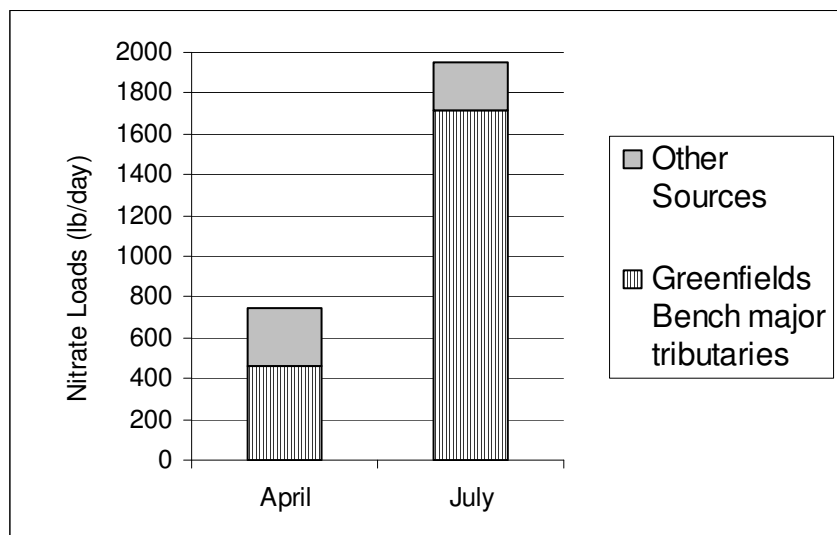
Figure 8-11. Nitrate Loading Contribution to the Muddy Creek at Vaughn USGS Site from Six Major Tributaries Originating on Greenfields Bench.

Greenfields Bench tributary data collected in 2000 by Miller, (2002). USGS data used in this comparison is the monthly (April or July) mean from 1996-2000 at the Muddy Creek at Vaughn station. A USGS mean from a 4-year period is used to offset variability in discharge levels because the two studies were not synoptic.

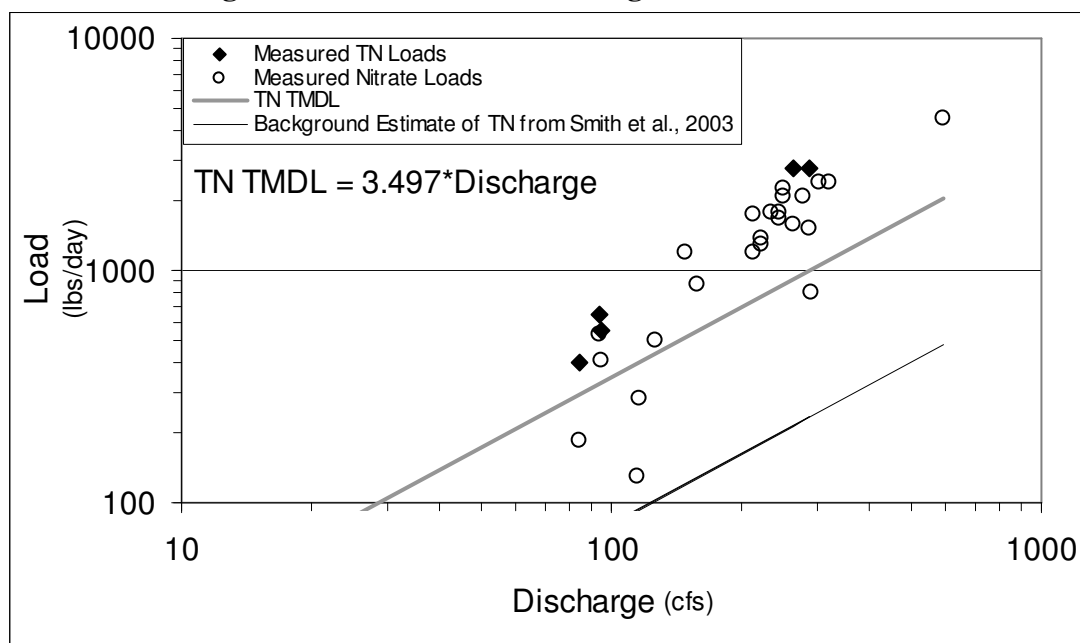
Figure 8-14. Muddy Creek Total Nitrogen TMDL and Background Loads Compared to Measured Total Nitrogen and Nitrate Loads at Vaughn.

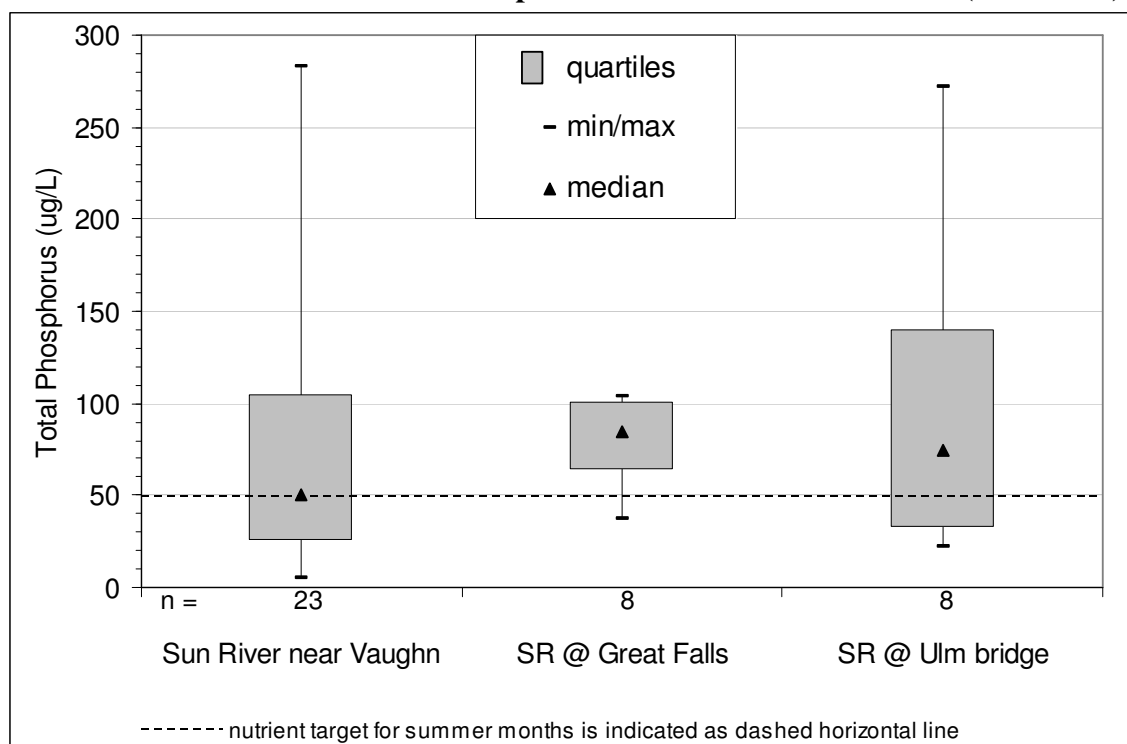
Figure 8-16. Lower Sun River Total Phosphorus Summer Concentrations (1996-2003).

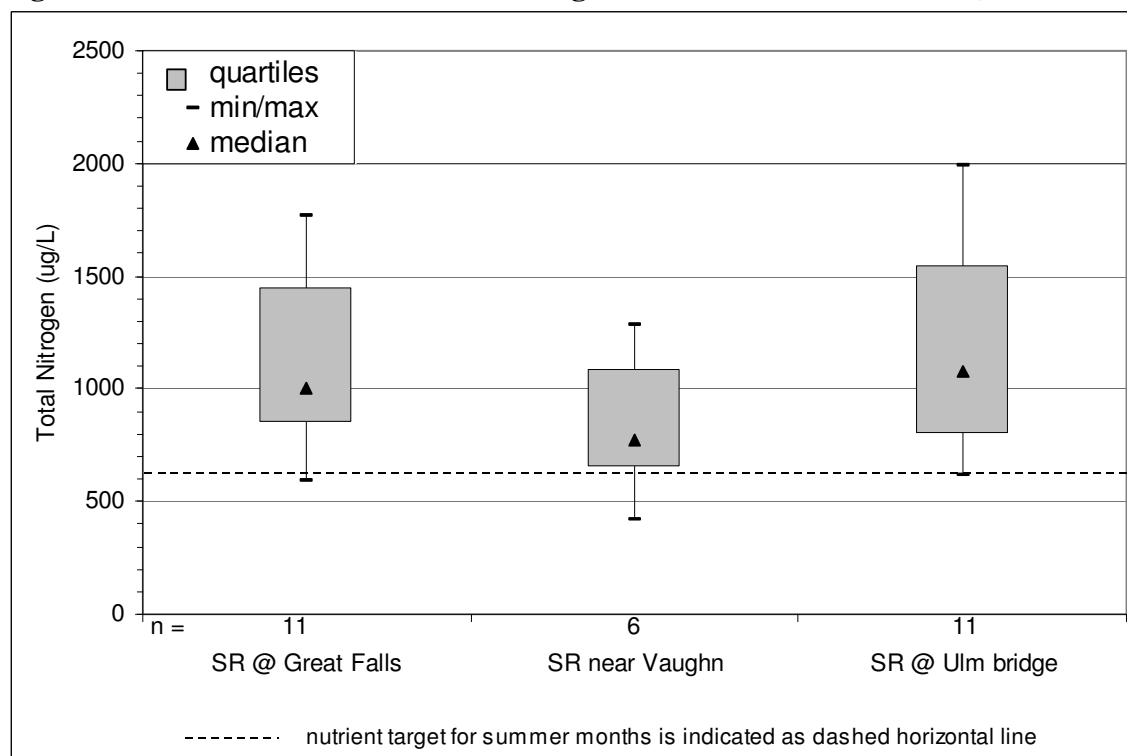
**Figure 8-17. Lower Sun River Total Nitrogen Summer Concentrations (1996- 2003).**

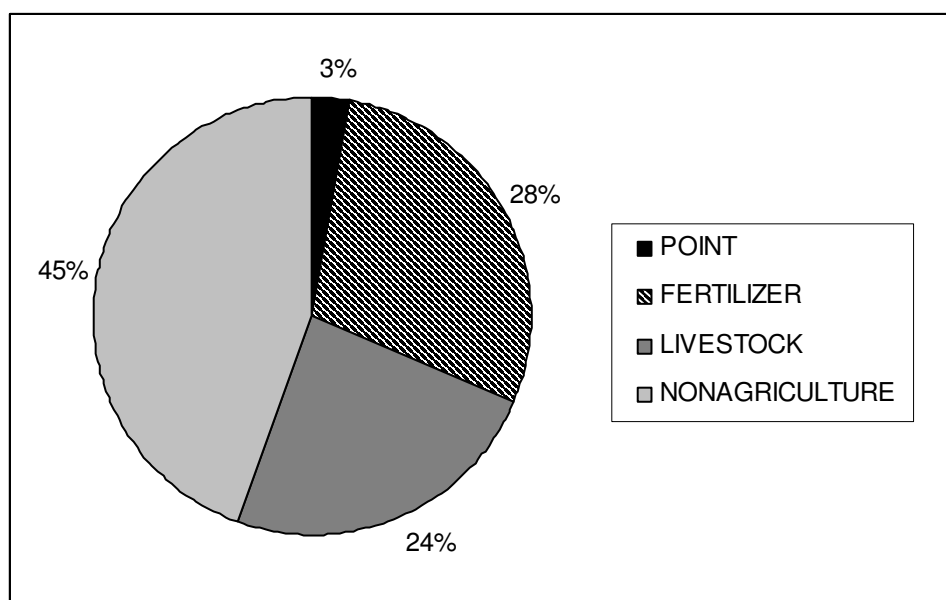
Figure 8-18. SPARROW Model Results: Estimated Total Phosphorus Source Loading in the Sun River Watershed.

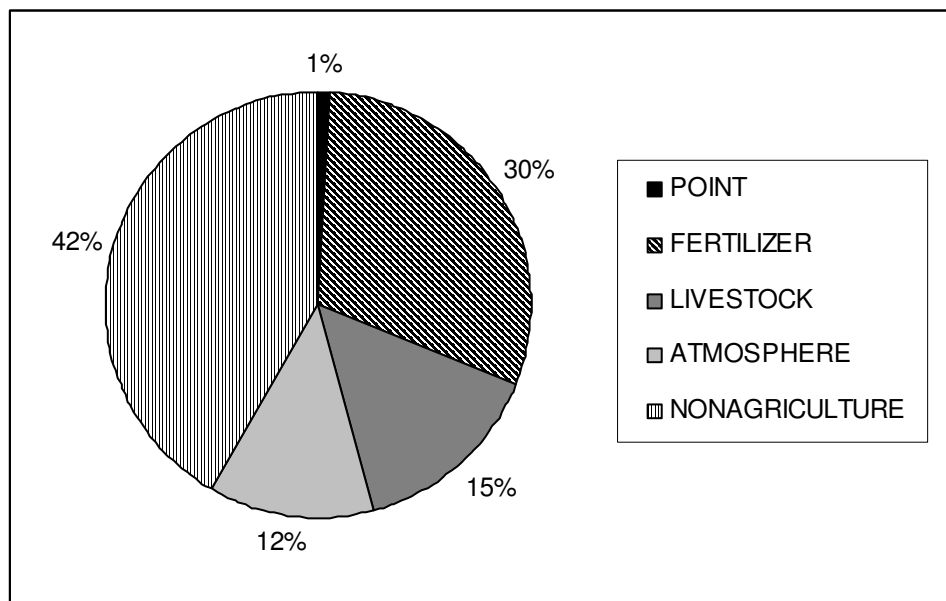
Figure 8-19. SPARROW Model Results: Estimated Total Nitrogen Source Loading in the Sun River Watershed.

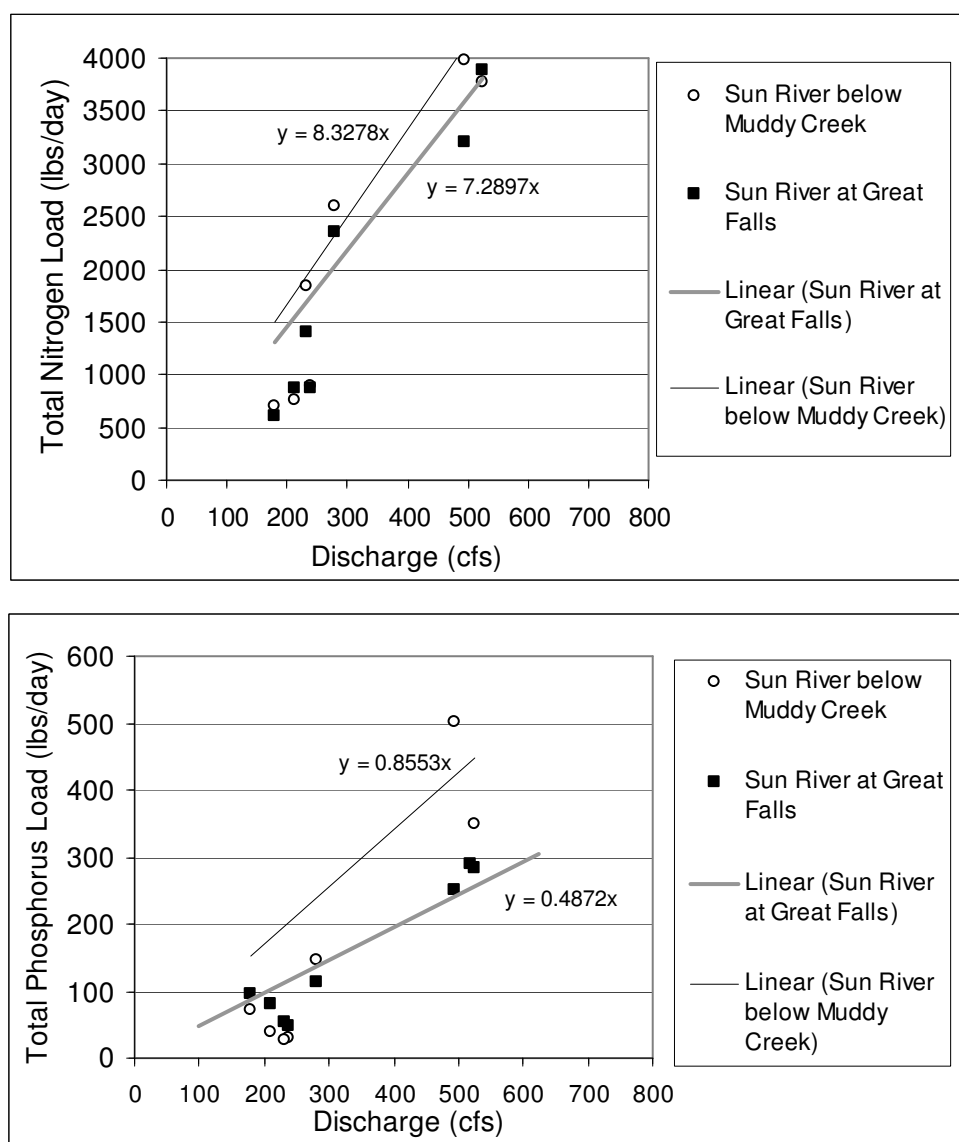
Figure 8-20. Comparison of Nutrient Loads in the Lower Sun River Near Vaughn and Great Falls.

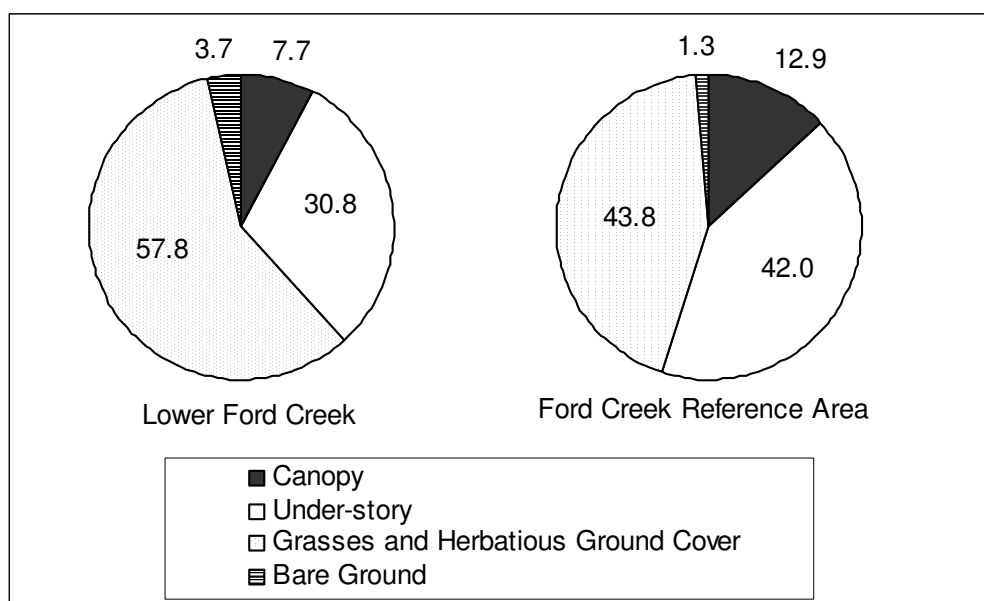
Figure 9-1. Riparian Community Comparison of Impaired Reach and Reference Reach of Ford Creek.

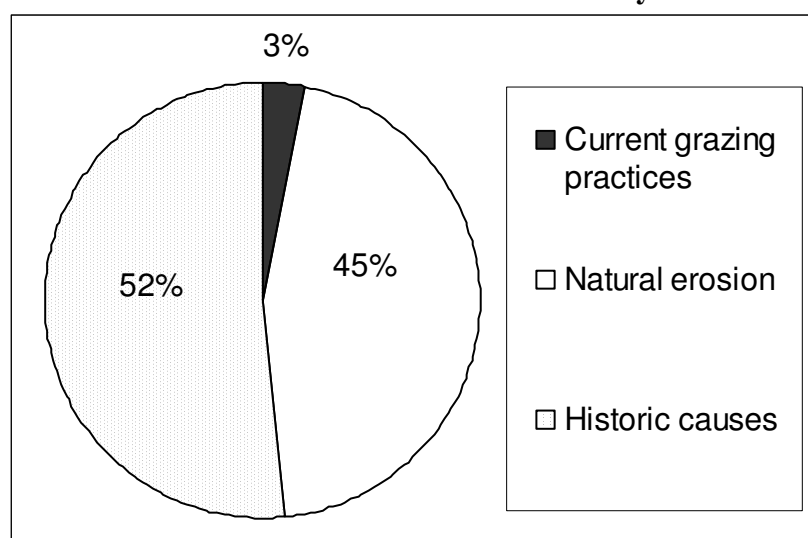
Figure 9-2. Percent of Stream Bank Erosion Sediment Yield by Source Category.

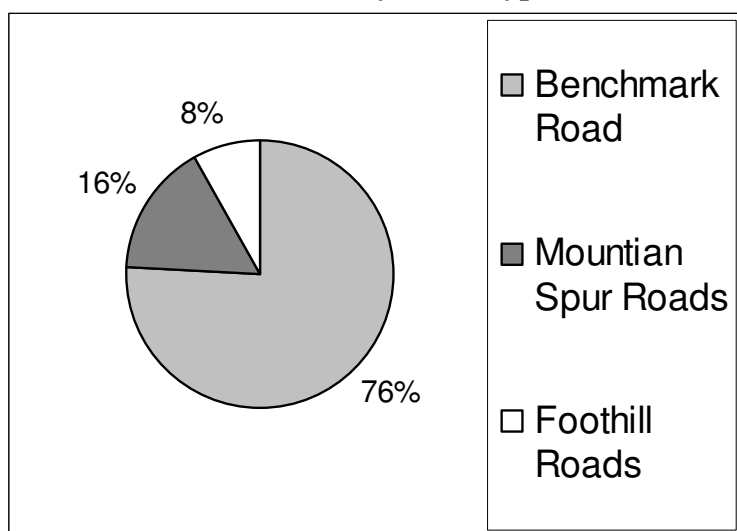
Figure 9-3. Percent of Road Sediment Yield by Road Type.

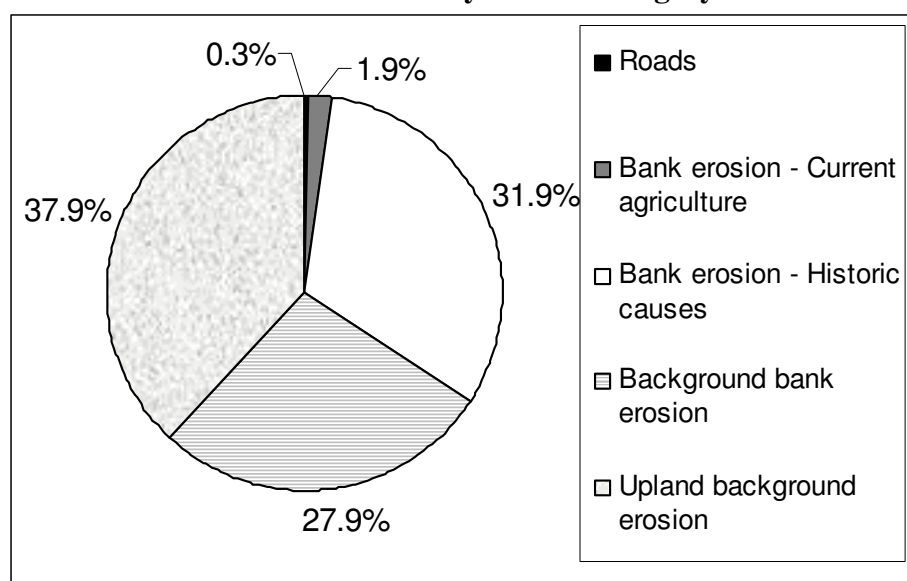
Figure 9-4. Percent of Total Sediment Yield by Source Category.

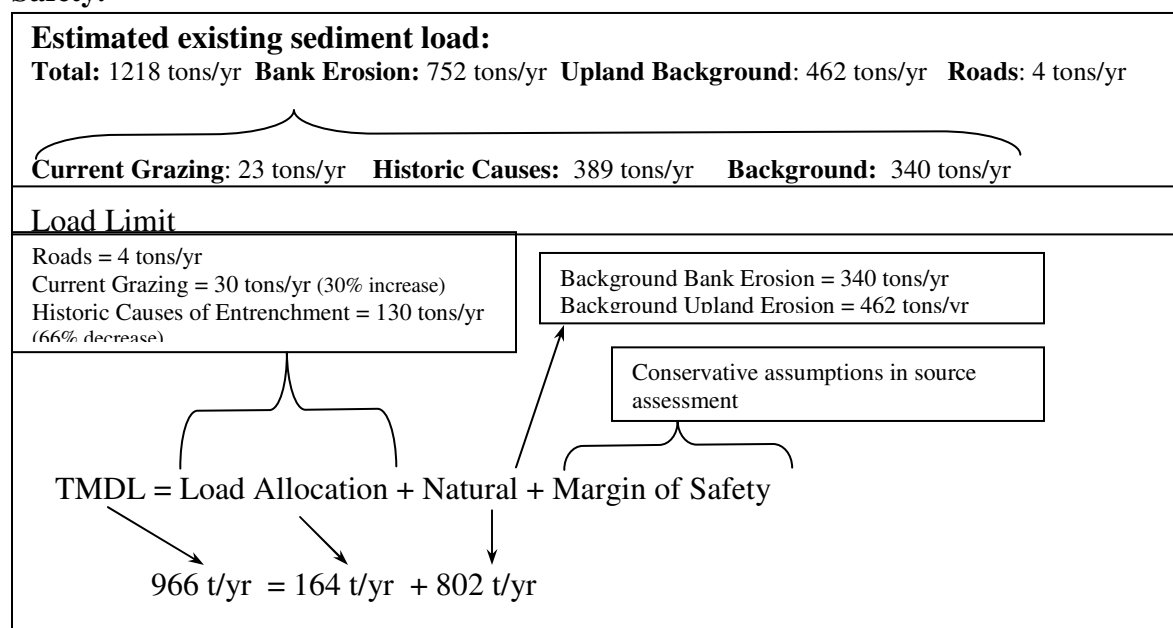
Figure 9-5. Ford Creek Estimated Existing Loads, TMDL, Allocation, and Margin of Safety.

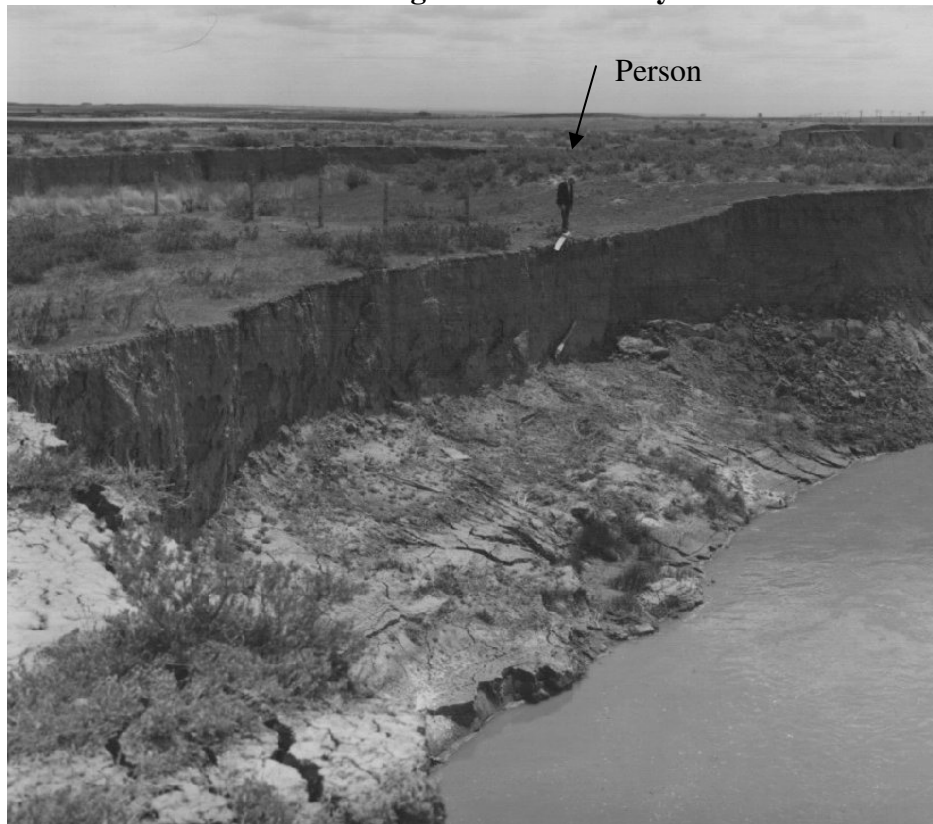
Figure 9-7. Mass Bank Erosion Occurring on Lower Muddy Creek.

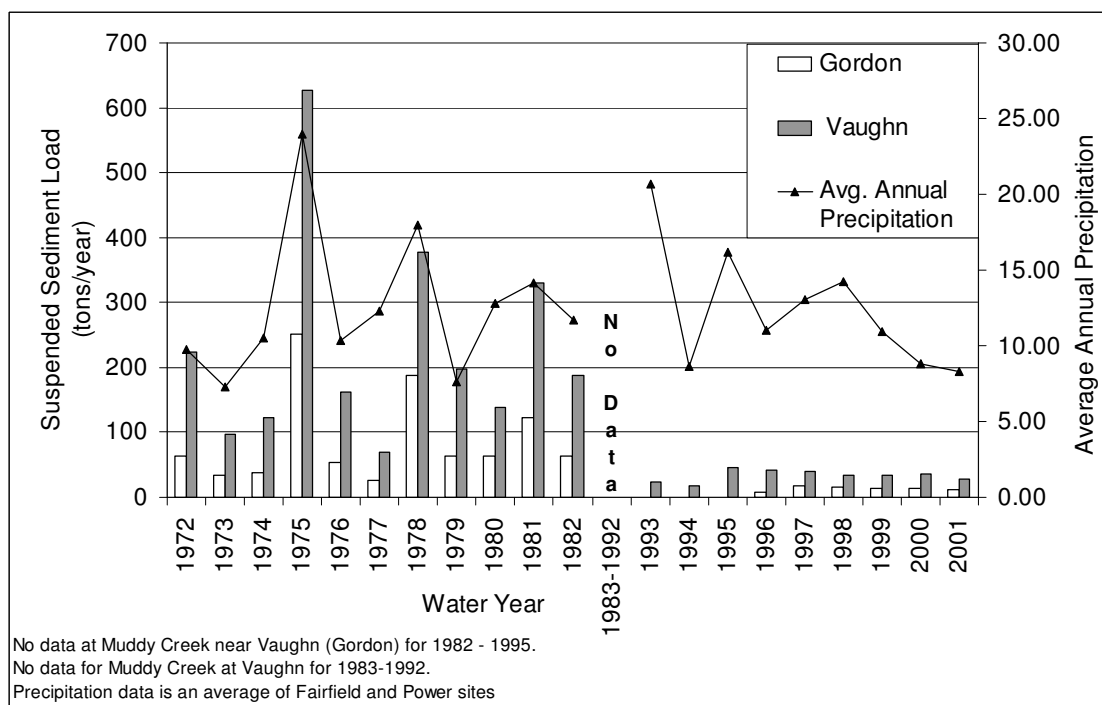
Figure 9-11. USGS Calculated Suspended Sediment Loads and Average Annual Rainfall 1972-2001.

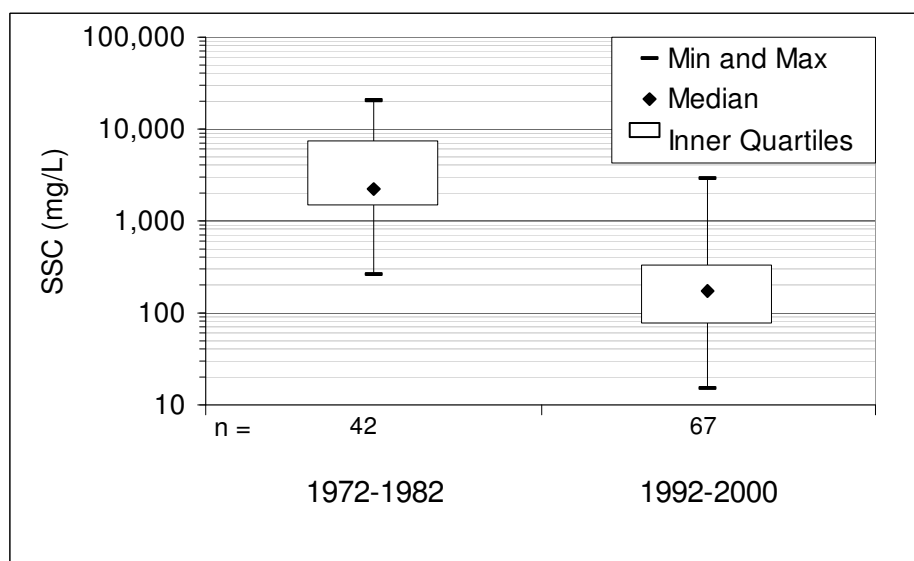
Figure 9-13. Suspended Solids Concentration at Muddy Creek at Vaughn USGS Station 1972-1982 and 1992-2000.

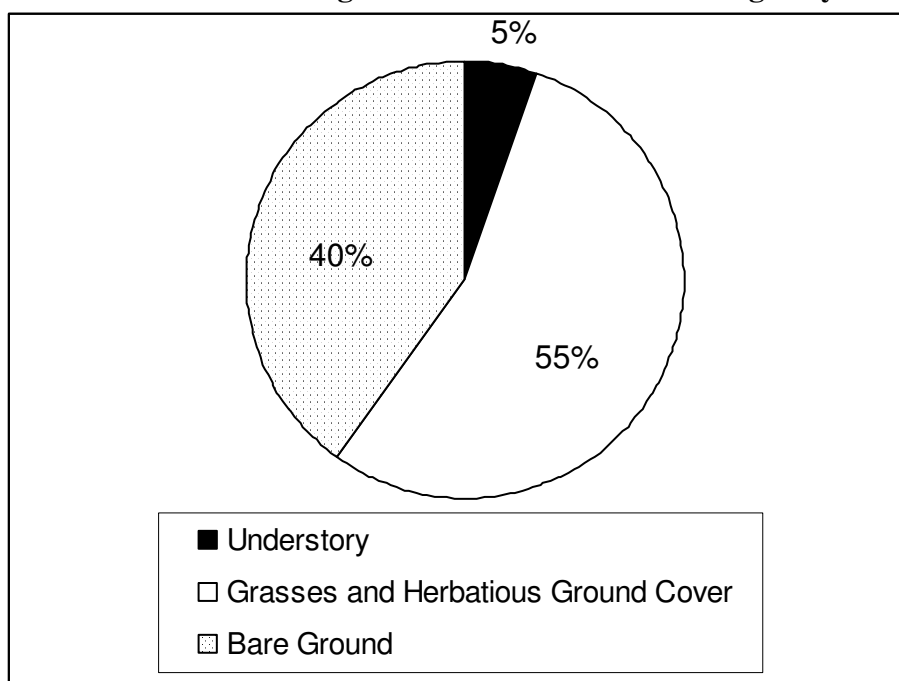
Figure 9-19. Sun River Bank Full Vegetation Assessment Above Highway 287.

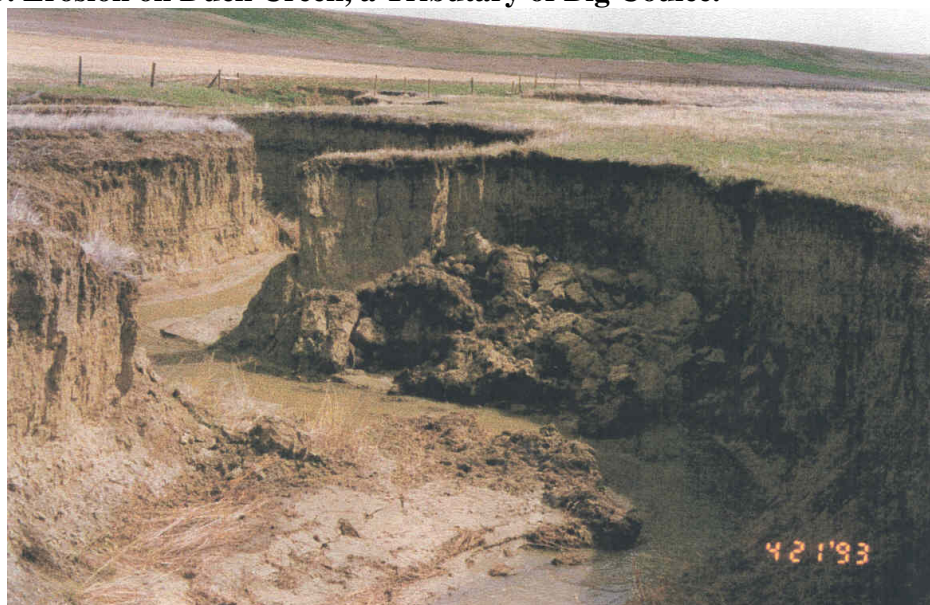
Figure 9-23. Erosion on Duck Creek, a Tributary of Big Coulee.

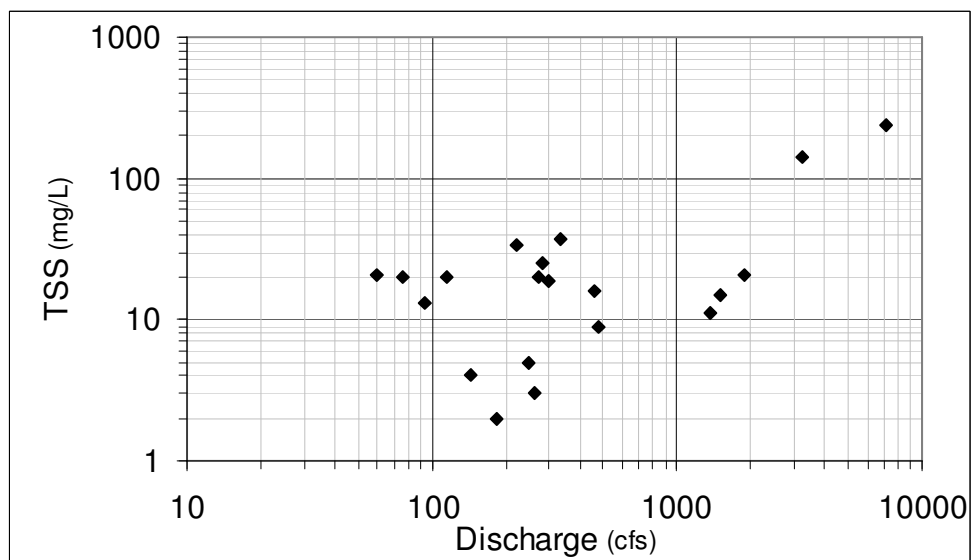
**Figure 9-25. Sun River Total Suspended Solids Concentration and Discharge Relationship Near Simms.**

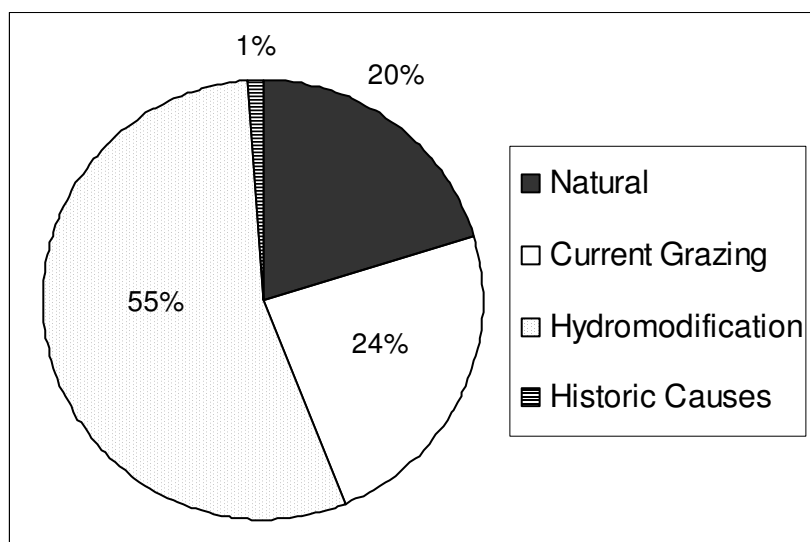
Figure 9-26. Percent of Stream Bank Erosion Sediment Yield by Source Category, Upper Sun River.

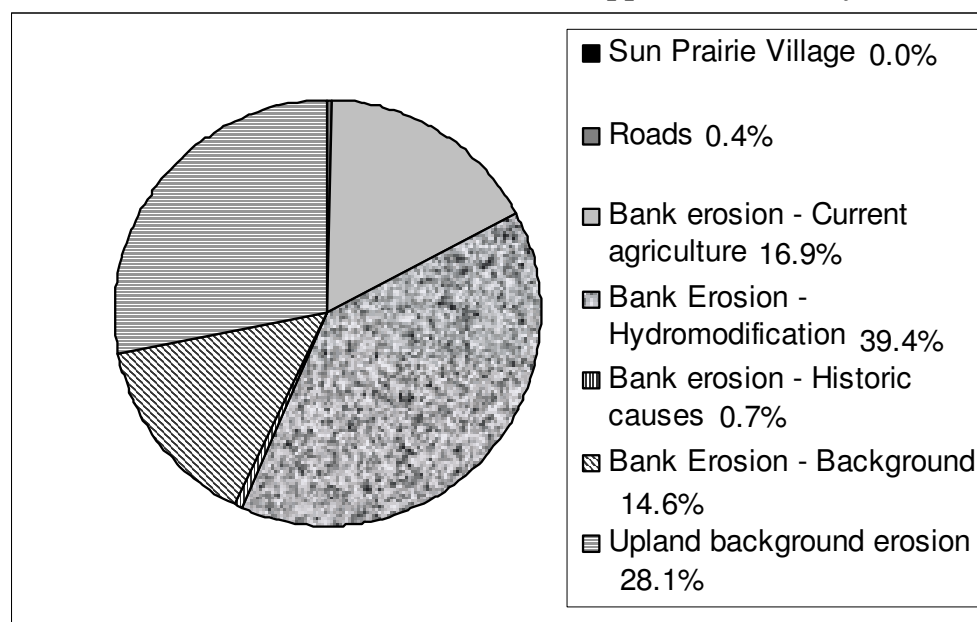
Figure 9-27. Percent of Total Sediment Yield in the Upper Sun River by Source Category.

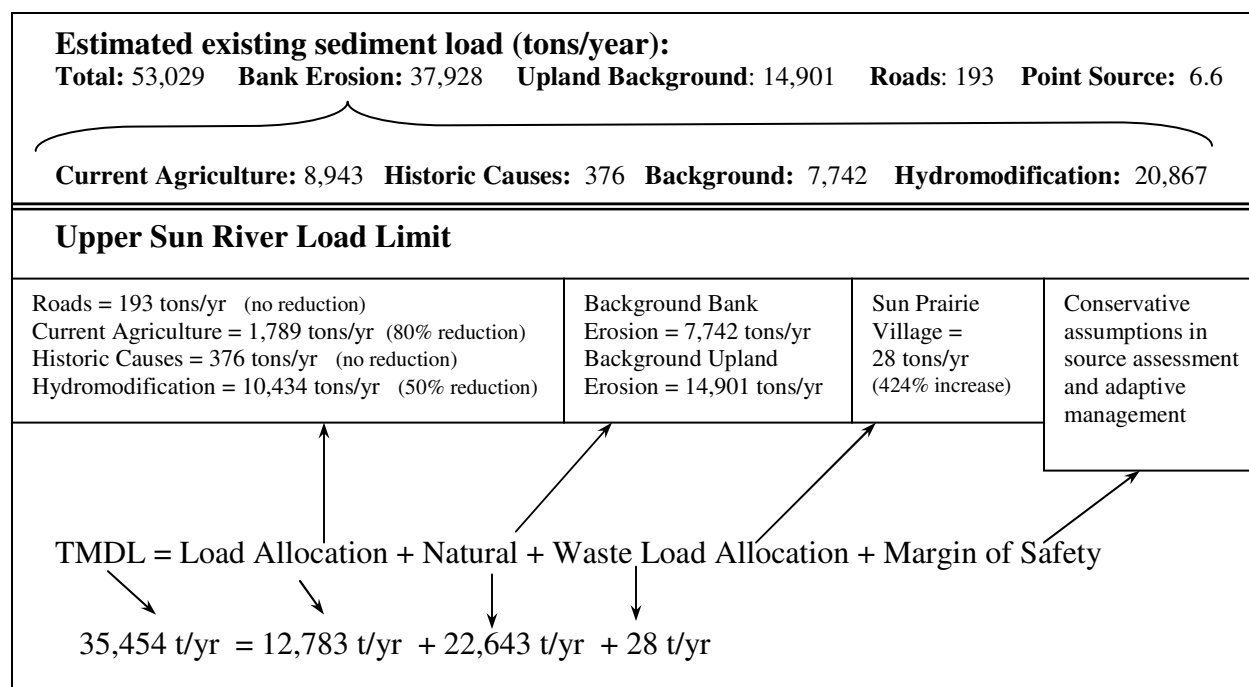
Figure 9-28. Upper Sun River Estimated Existing Loads, TMDL, Allocation, and Margin of Safety.

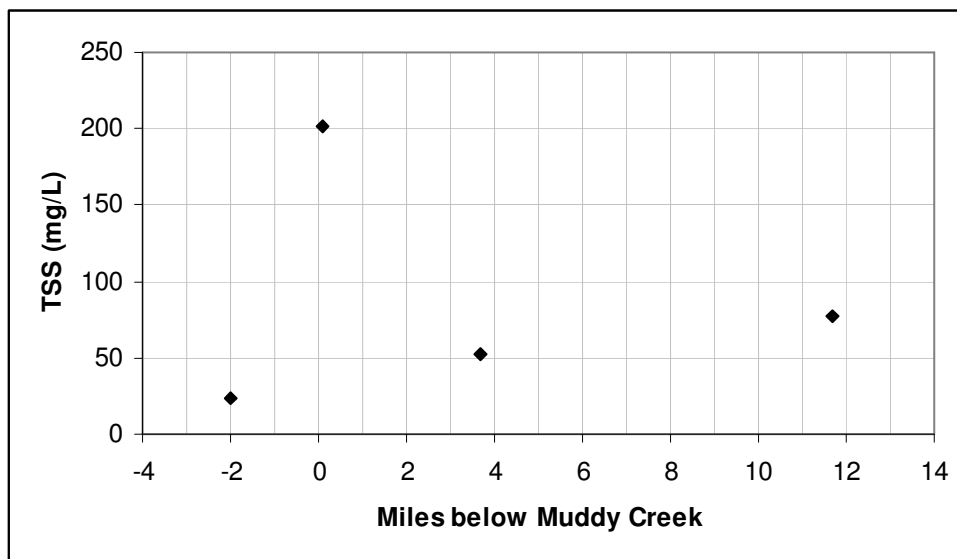
Figure 9-29. Mean TSS Concentrations Below Muddy Creek During Two Sampling Events, September 1980.

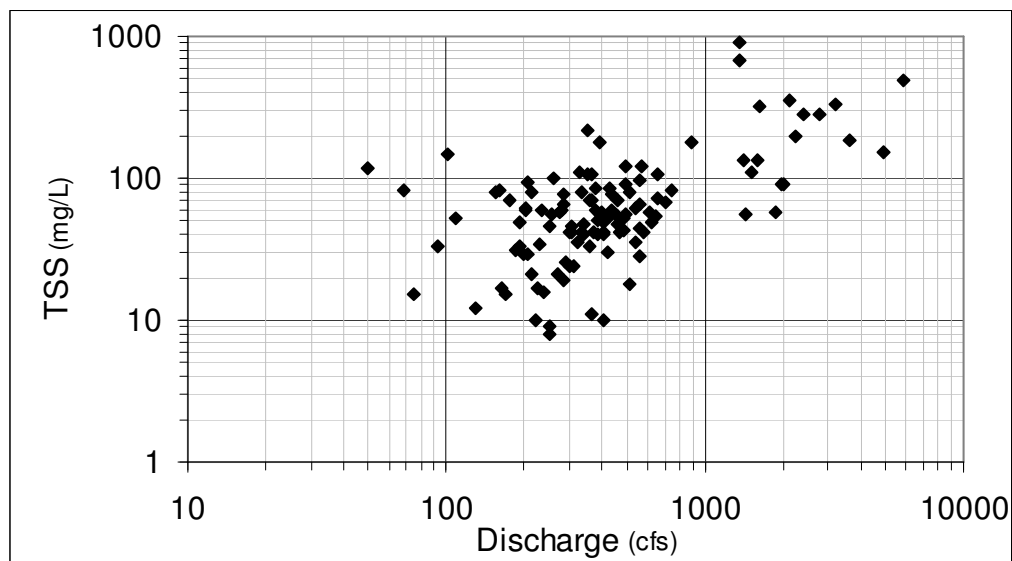
Figure 9-31. Suspended Sediment Concentration and Flow Relationship at Sun River Near Vaughn USGS Gauge.

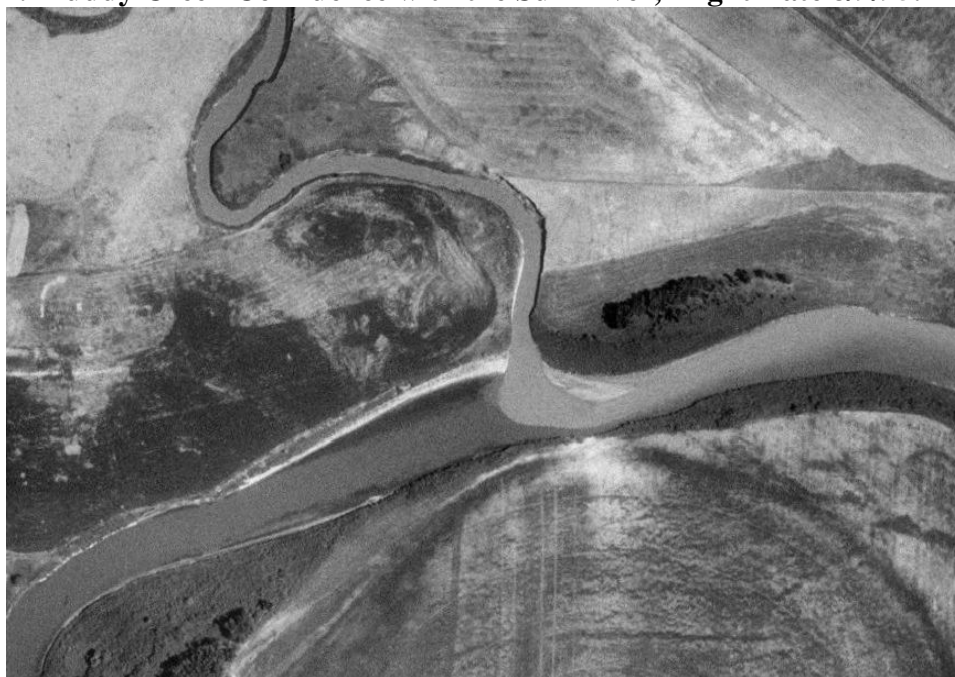
Figure 9-32. Muddy Creek Confluence with the Sun River, Flight Date 8/9/95.

Note the difference in turbidity between Muddy Creek and Sun River

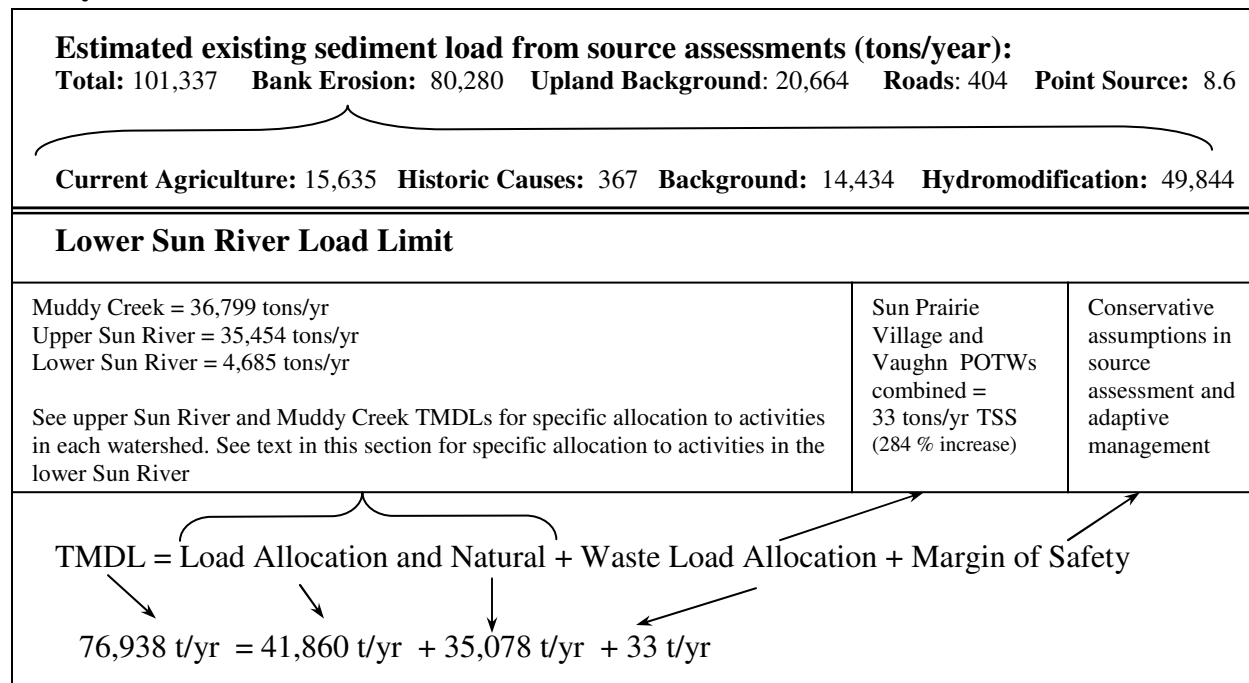
Figure 9-33. Sun River Estimated Existing Loads, TMDL, Allocation, and Margin of Safety.

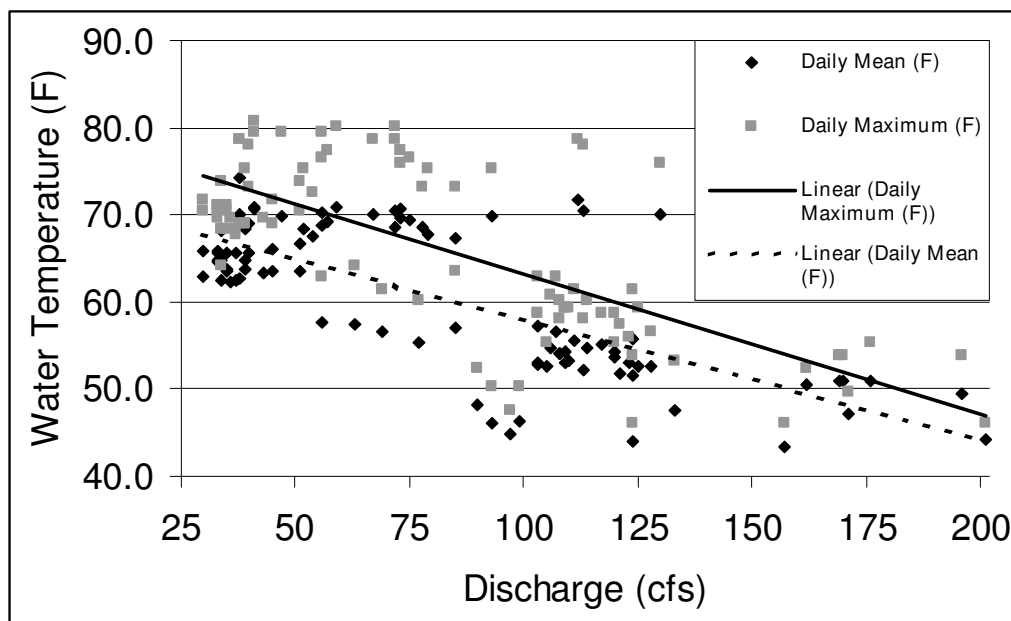
Figure 10-1. Temperature vs. Mean Daily Flow Graphs Comparing Flow to Water Temperature Near Simms from 21 July – 20 October 2003.

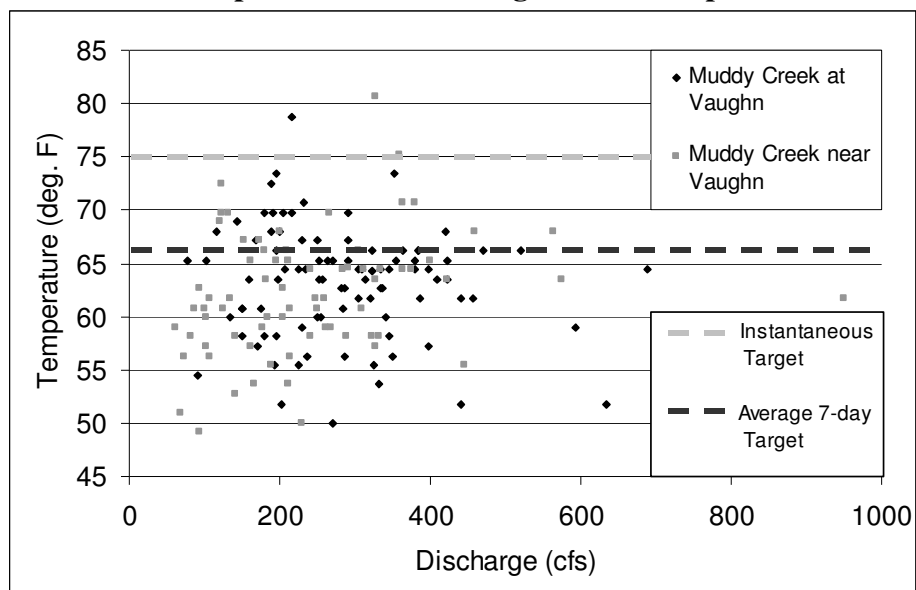
Figure 10-3. Muddy Creek at Vaughn and Muddy Creek Near Vaughn Summer (July - August) Discrete Water Temperature vs. Discharge Relationship.

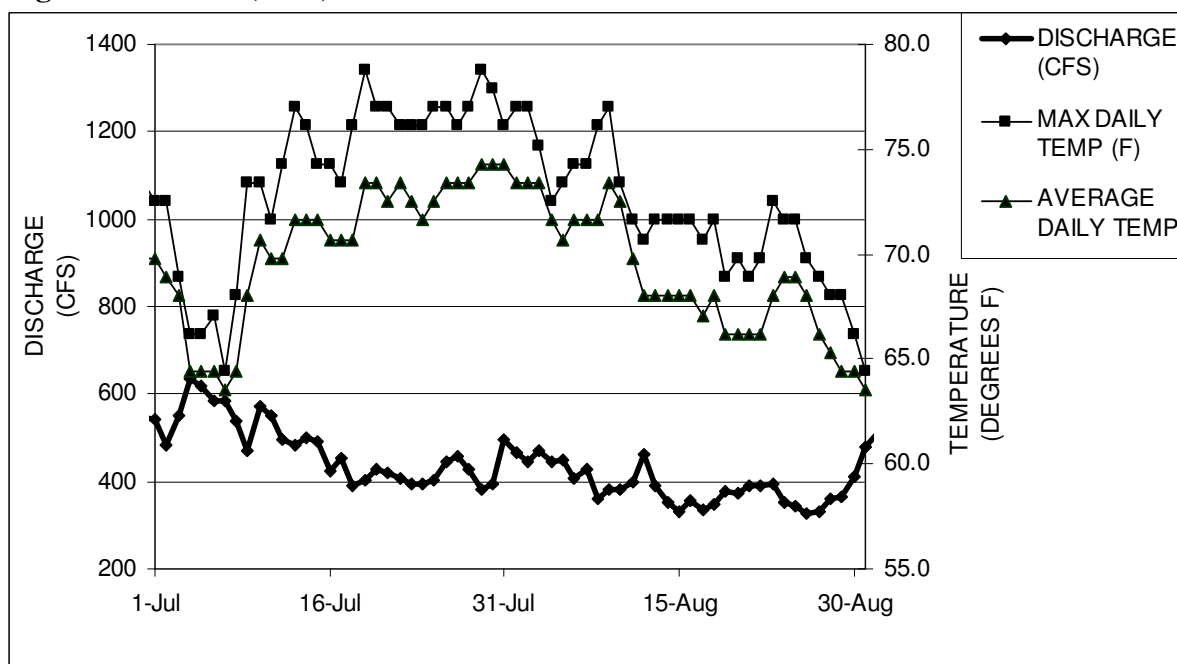
Figure 10-4. Relationship Between Water Temperature and Discharge at Sun River at Vaughn USGS Site (2000).

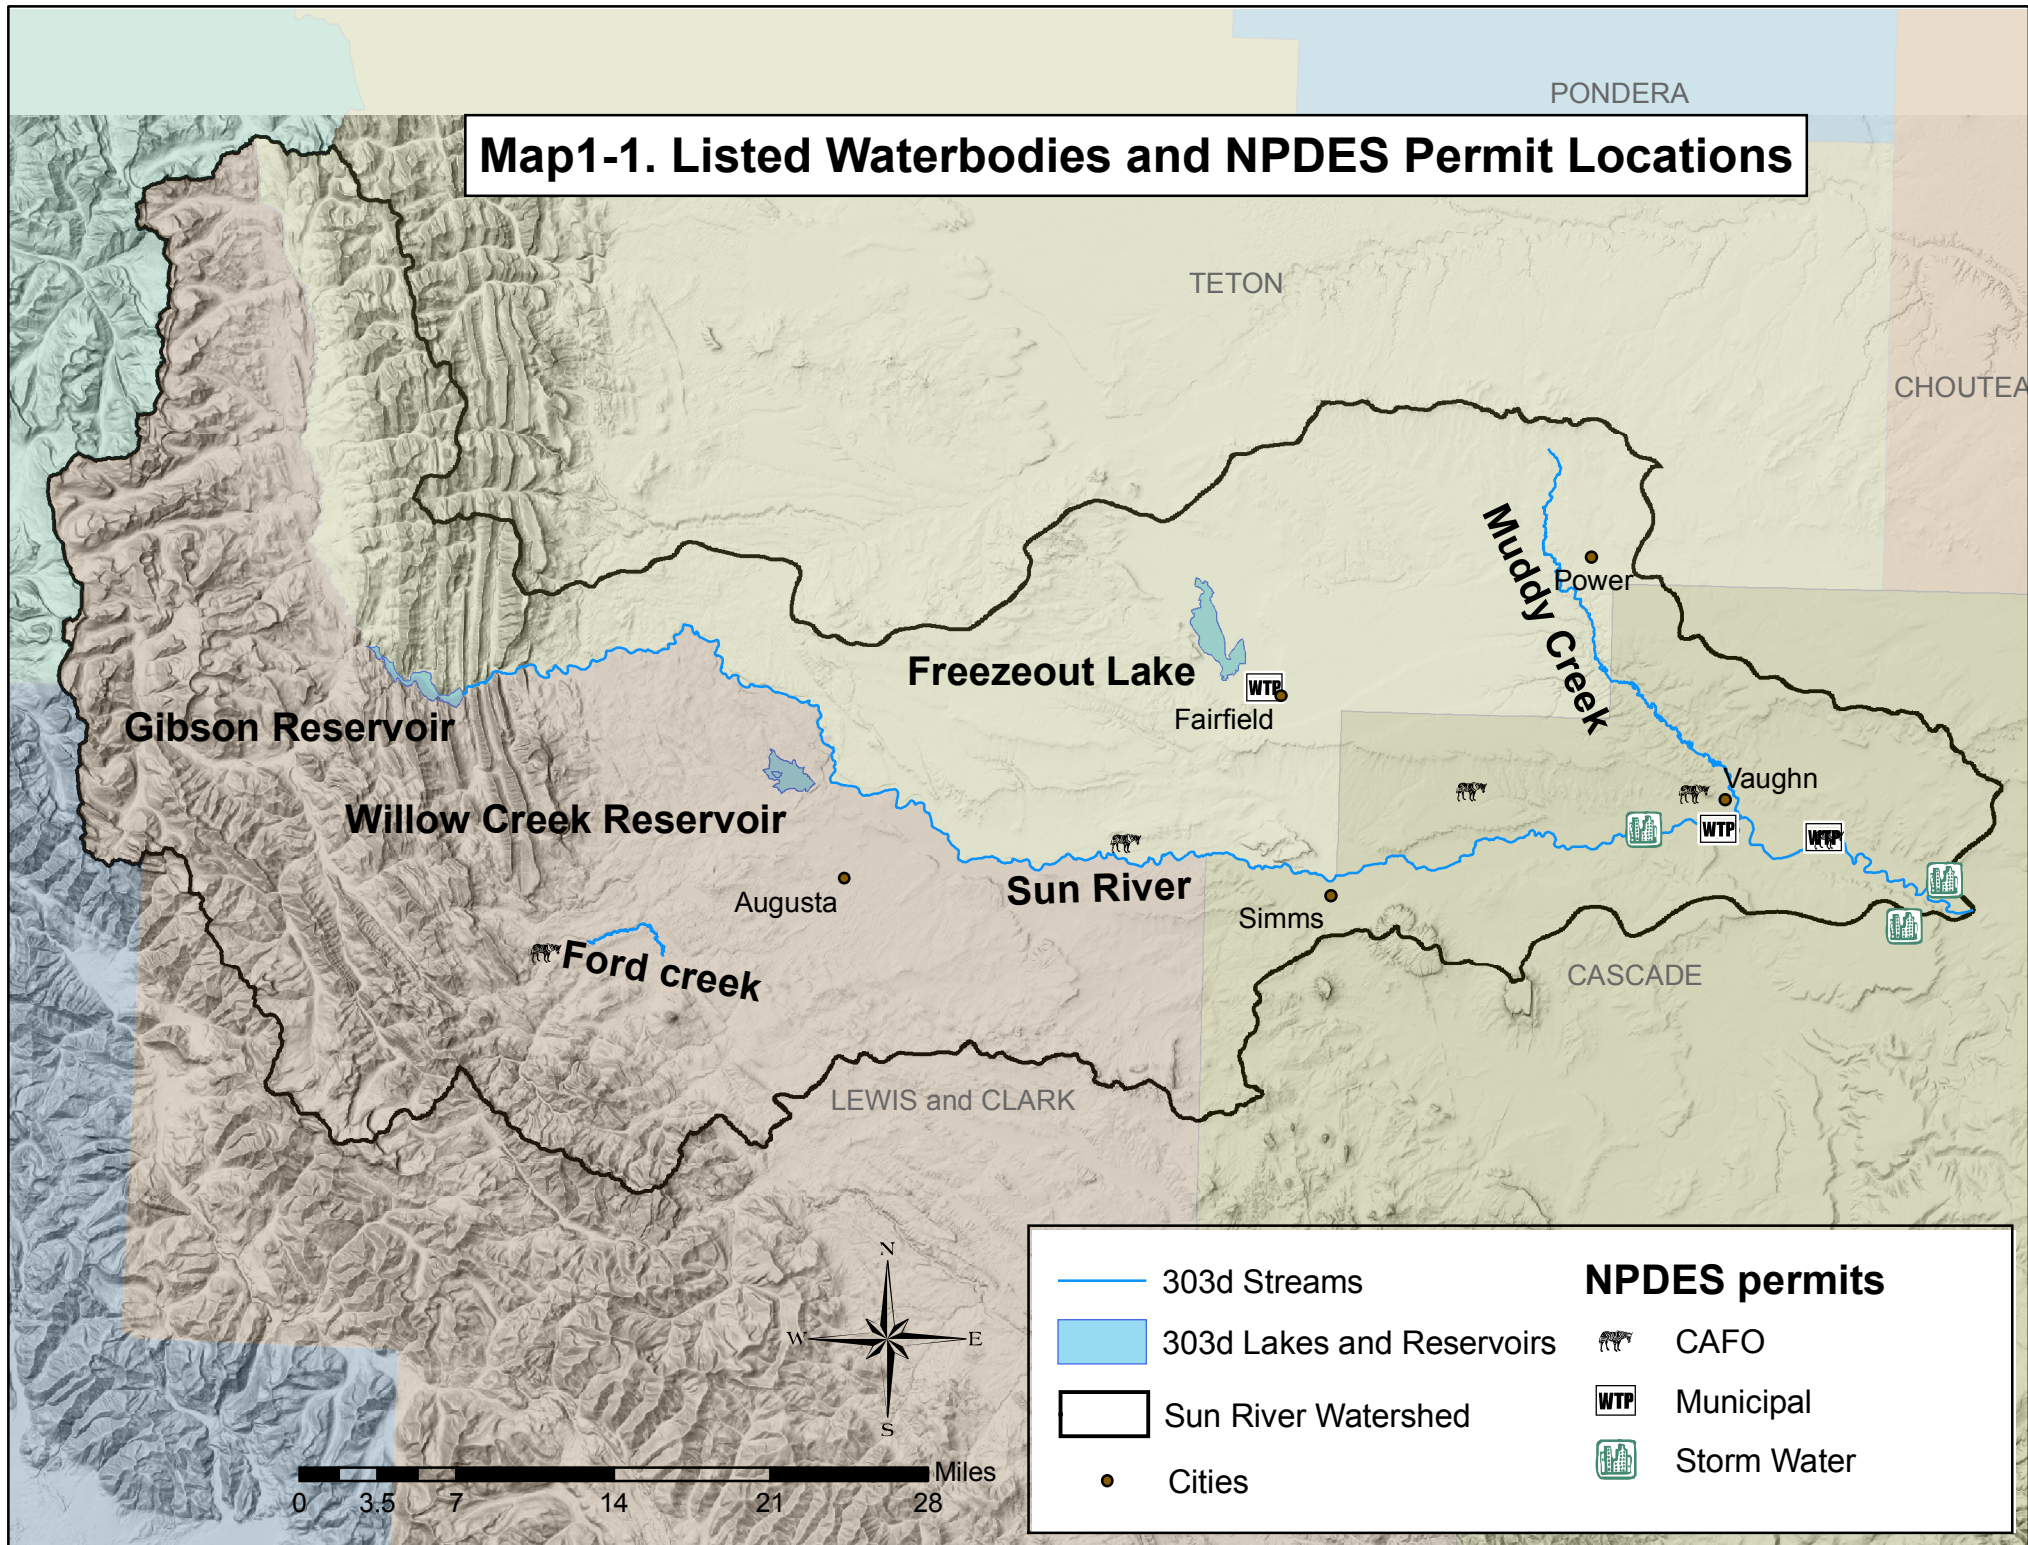
Map1-1. Listed Waterbodies and NPDES Permit Locations
